U.S. DEPARTMENT OF AGRICULTURE  
FOREST SERVICE

Slope Stability Hazard Assessment  
of  
Hatchery Fire Complex  
Wenatchee National Forest

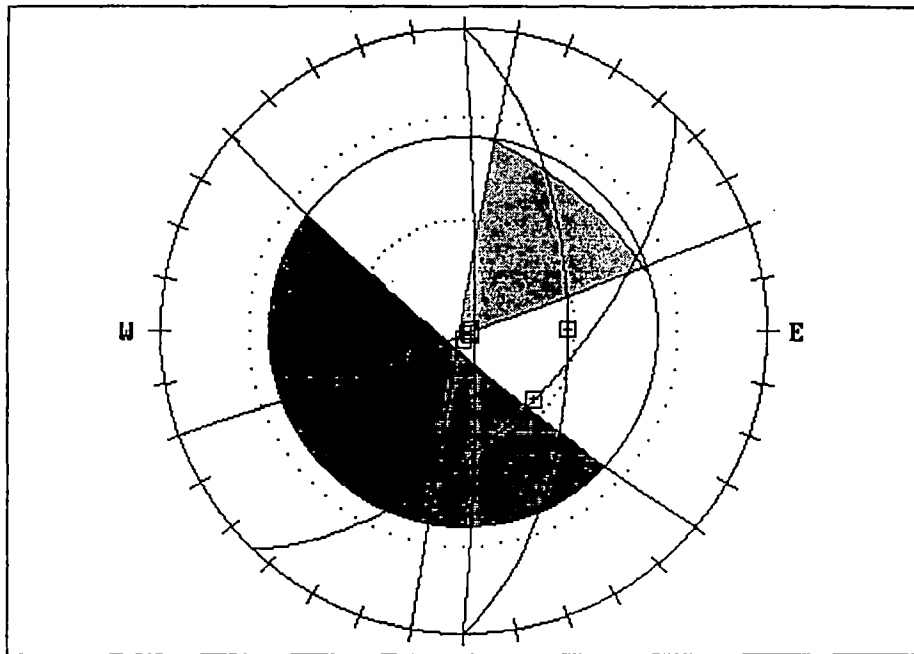
AREA T-1, LINE 1, CELL 1, 3,900 FT.

STEREONET PROJECTION OF MAPPED OUTCROP DISCONTINUITIES WHICH  
DISPLAYS POTENTIAL FOR TOPPLING FAILURE (Shaded wedge-shaped area)  
AND WEDGE FAILURE (Shaded pie-shaped area)

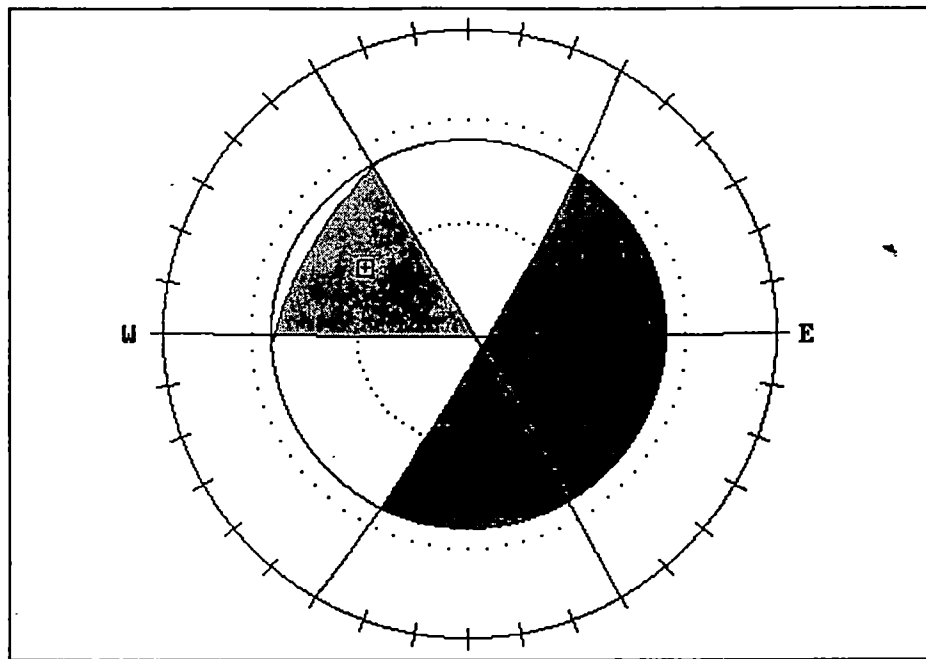
AREA T-5, LINE 1, CELL 2, 3,500 ft.

STEREONET PROJECTION OF MAPPED OUTCROP DISCONTINUITIES WHICH  
DISPLAYS POTENTIAL FOR TOPPLING FAILURE (Shaded wedge-shaped area)

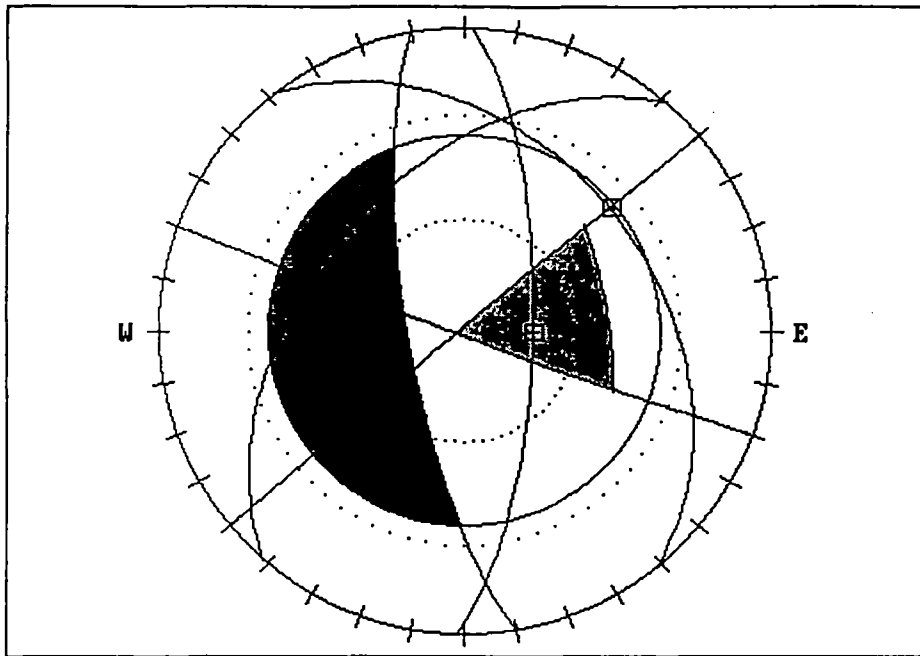
AREA T-6, LINE 5, CELL 1, 2,300 ft.

STEREONET PROJECTION OF MAPPED OUTCROP DISCONTINUITIES WHICH  
DISPLAYS POTENTIAL FOR TOPPLING FAILURE (Shaded wedge-shaped area)

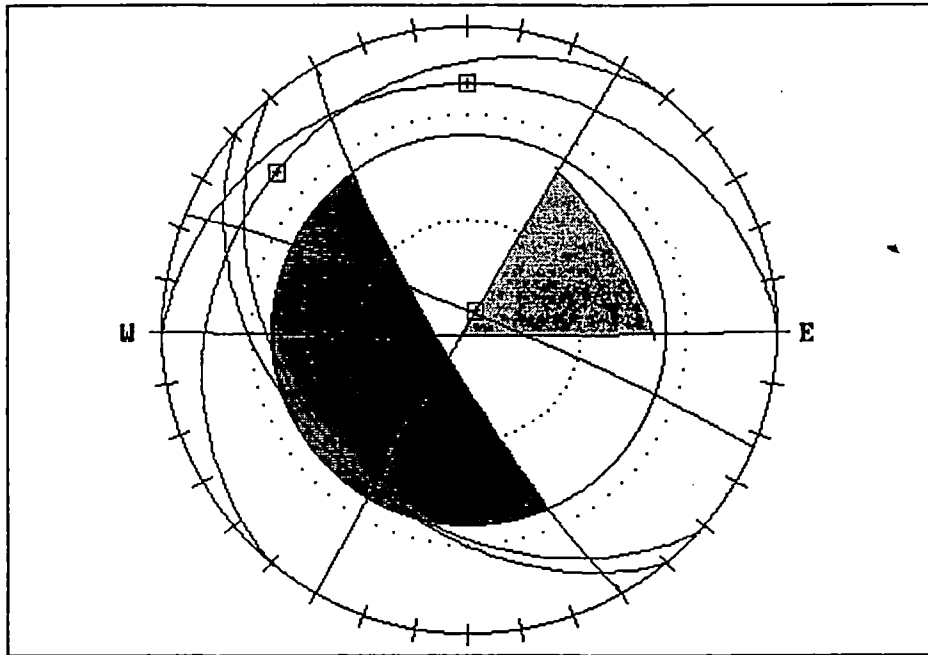
AREA T-6, LINE 3, CELL 1/4,000 FT.

STEREONET PROJECTION OF MAPPED OUTCROP DISCONTINUITIES WHICH  
DISPLAYS POTENTIAL FOR TOPPLING FAILURE (Shaded wedge-shaped area),  
PLANE AND WEDGE FAILURE (Shaded pie-shaped area)

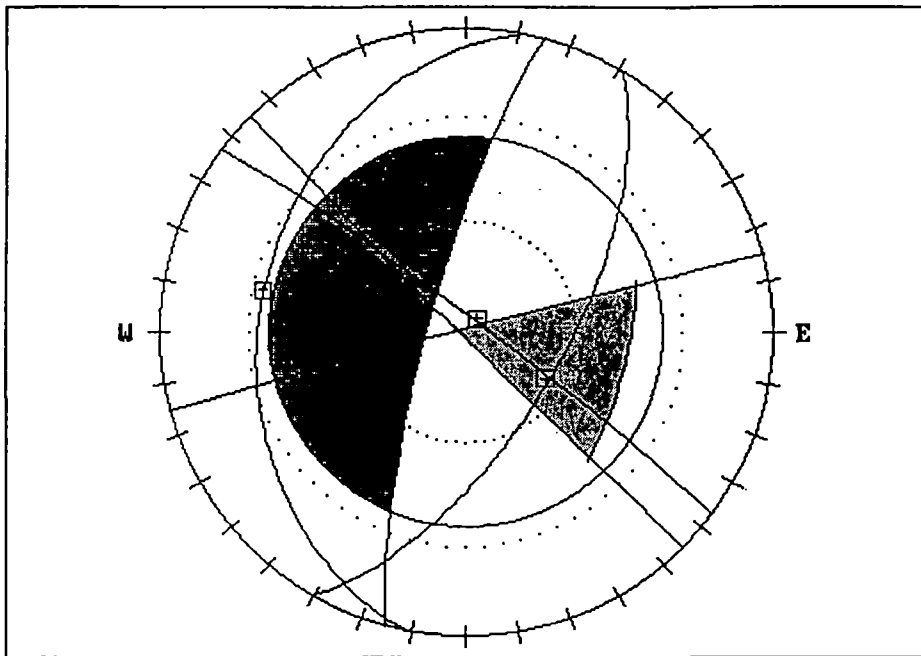
### AREA T-11, LINE 1, CELL 3

STEREONET PROJECTION OF MAPPED OUTCROP DISCONTINUITIES WHICH  
DISPLAYS POTENTIAL FOR TOPPLING FAILURE (Shaded wedge-shaped area)

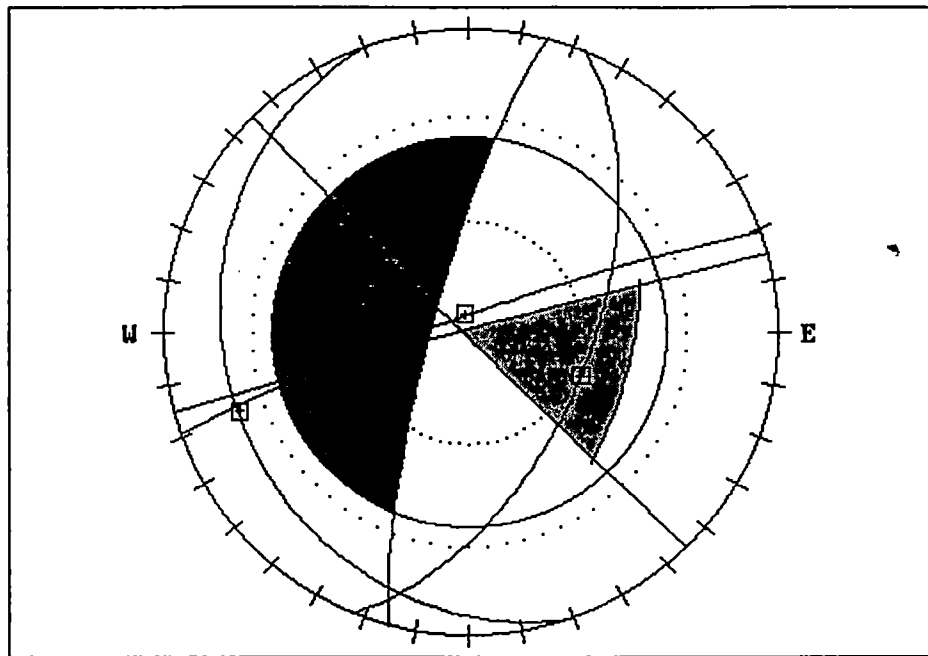
#### AREA T-11, LINE 1, CELL 4

STEREONET PROJECTION OF MAPPED OUTCROP DISCONTINUITIES WHICH  
DISPLAYS POTENTIAL FOR TOPPLING FAILURE (Shaded wedge-shaped area)

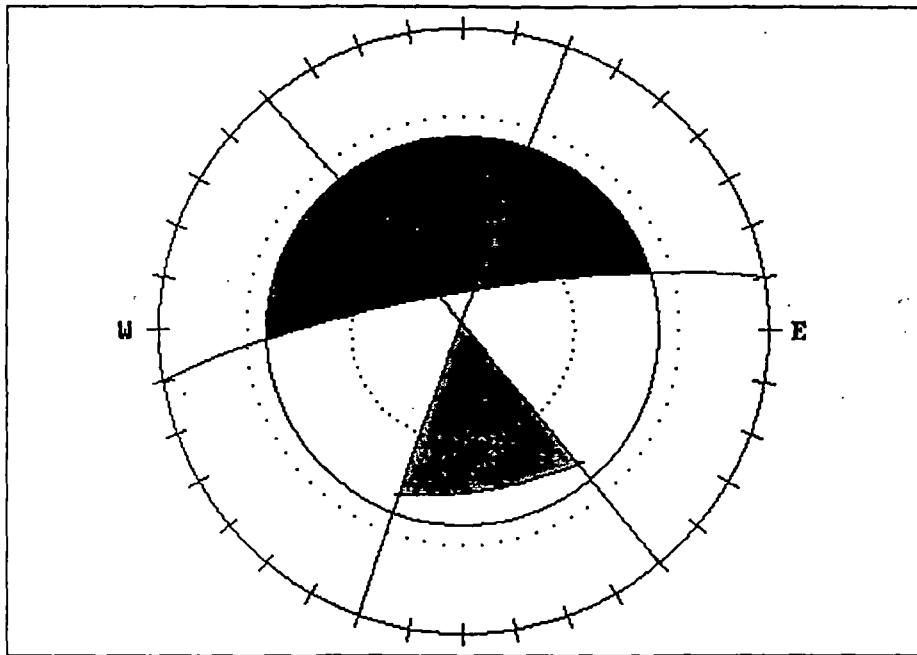
AREA W-1, LINE 1, CELL 2

STEREONET PROJECTION OF MAPPED OUTCROP DISCONTINUITIES WHICH  
DISPLAYS POTENTIAL FOR PLANE FAILURE (Shaded pie-shaped area)
